AssetCare Counts #18

January 2013

► Operational Deflection Shape Analysis Aids Gearbox Vibration Diagnostics

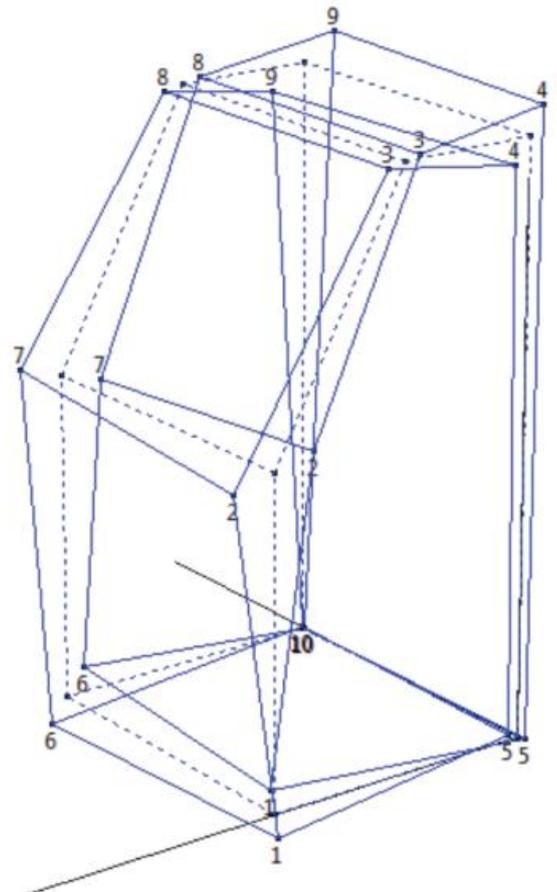
Figure 1 - Gearbox Casing ODS

From the ODS data (Figure 1), a dominant torsional vibration mode could clearly be identified. It was therefore evident that the gearbox casing was lacking in torsional stiffness. As the casing experiences torsional flex, the meshing gear pairs will experience small relative motion, leading to slight imperfections in the meshing geometry. These imperfections account for the high audible noise levels experienced in the vicinity of the gearbox.

Due to the marked rise in overall vibration levels observed when the reconditioned gearbox was installed, coupled with the high audible noise levels experienced in the immediate proximity of the gearbox, the client was concerned that this gearbox might not function satisfactorily for a sufficient length of time. Drawing on the dominance of the torsional vibration mode shape exhibited by the gearbox, the primary cause for the high levels of both vibration and noise could be clearly established, backed up by solid experimental evidence as measured in the ODS analysis: the gearbox lacks torsional stiffness. This information may be used to adjudicate the root cause of the vibration issues experienced with the gearbox: a torsional vibration mode is to blame, as opposed to a defect or flaw in the gear teeth.

In this case study ODS analysis was found to be a clear aid in diagnosing an issue experienced with an industrial gearbox, facilitating sound engineering judgement based on reliable information. A defect or flaw in the gear teeth, whether due to manufacturing error or wear, would require replacement of the affected gears, while torsional stiffening of the gearbox casing requires modification to the casing. In this case, replacement of the gears would likely have contributed very little to a reduction in the high vibration levels, whereas modification of the gearbox casing stands would significantly reduce the problematic vibrations. Operational deflection shape analysis has therefore served to pinpoint the cause of the high vibration levels as a structural issue with the gearbox casing.

Due to the size and criticality of the gearbox, modification to the gearbox casing was not an option. Being able to pinpoint the issue with the gearbox prevented expenditure of significant resources on proposed solutions that would not have adequately addressed the root cause of the problem.
