Asset Care Counts

September 2015

Innovative Condition Monitoring of Damaged Gear Teeth

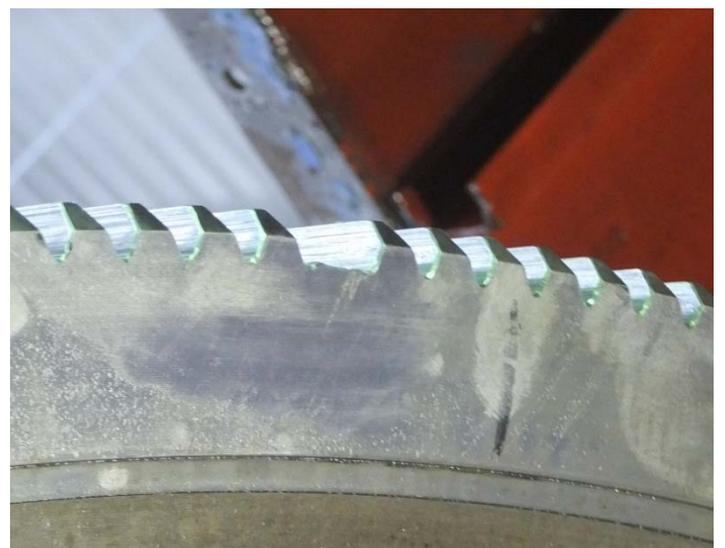
Figure 1 - Damaged Gear Set

ALS was approached to examine a gearbox with many compromised teeth on multiple gears. New gears had been commissioned but the lead time to delivery was several months.

Considering the damage already evident and the short period until gear set replacement, the key failure mode of most concern was fracture of the gear teeth.

Visual examination had been the most effective inspection method for this condition, however as this can only be done at intervals (due to the need to keep the gear box operating for production), ALS was consulted to implement a method of monitoring the gears in operation between the visual inspections.
